Conde McCullough Bridge Repair—South End

Coos Bay, OR
Submitted by BASF Corporation

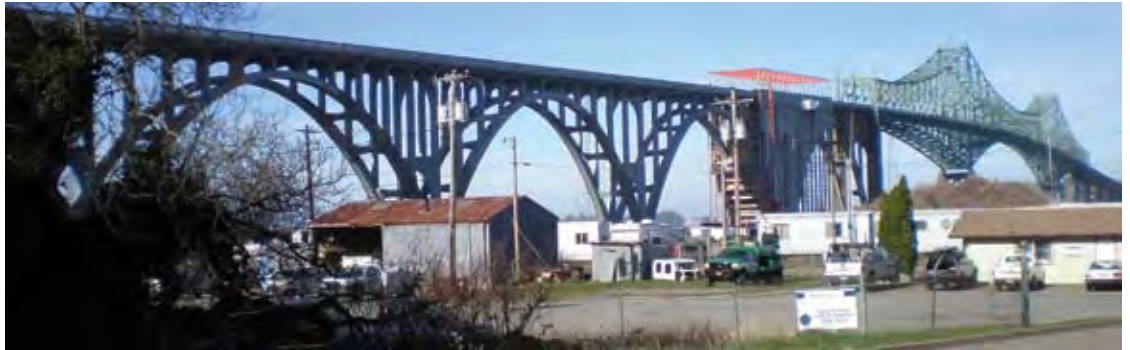
South end of the bridge. Enclosure is visible right before the steel midspan. Scope of work was to repair the South end, a 4-year project

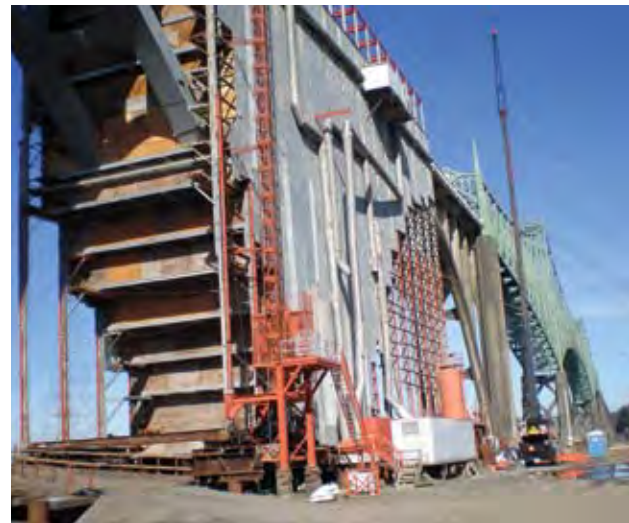
Up-close image of the enclosure showing a perspective of the size of the bridge and complexity of the project. The enclosure is roughly 100 ft (30.5 m) by 120 ft (36.5 m) long. Once the work inside is complete, the enclosure is dismantled and then moved down the line. At the end of the enclosure, you can see a stepping pattern as you follow from top to bottom. Each step represents a repair level—near the top there are “split levels”—16 total to address the complete structure

To address the severe weather conditions, a resilient, movable enclosure was built to create work platforms with multiple levels. Once the work was completed in the section covered by the enclosure, it was disassembled, moved, and reassembled to address the next section of the bridge to be restored. The unique enclosure, which is approximately 100 ft (30.5 m) tall and over 100 ft (30.5 m) long, operates on hydraulics to adjust for the varying height of the bridge. When the section repair was completed, it took approximately 1 month to move the complete enclosure forward to the next repair section.

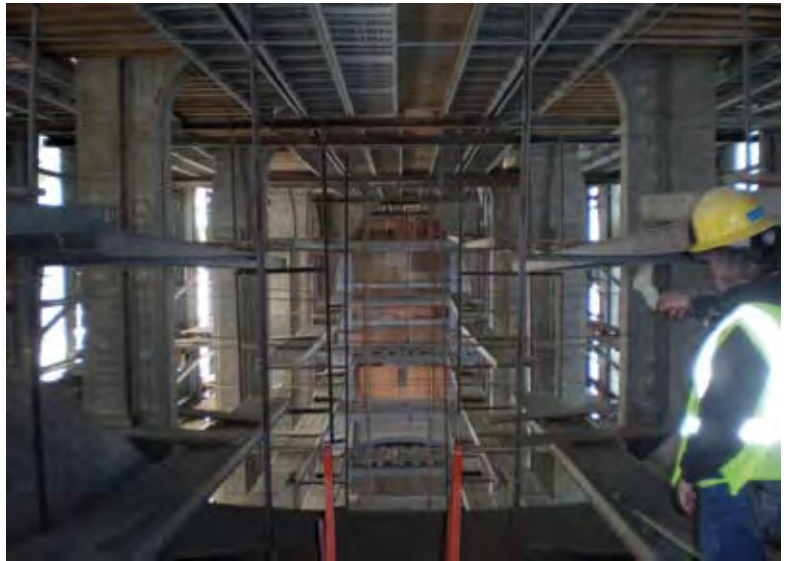
Inside the enclosure, showing the various levels and work platforms

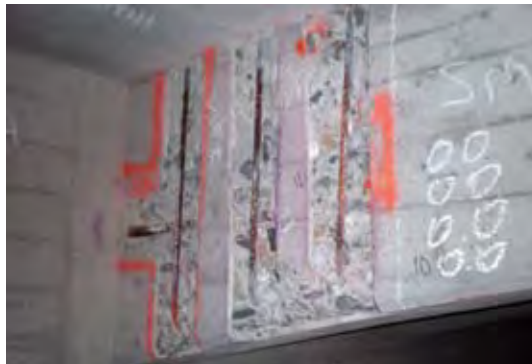
The repair has been prepared. Rather than cutting out reinforcing bar, the surrounding concrete is prepared and a box form will be built around it

While earlier projects in this series of bridges used a continuous mixer and rotor/stator pump to place the repair mortar, this bridge required a different solution. The multi-level enclosure called for a pump that was lightweight and mobile, allowing access on each level and on narrow scaffold planks. A Kenrich, diaphragm-type, hand-operated grout pump was used. After placing these portable pumps on tight scaffold areas, the material was pumped full depth both vertical and overhead, where complex forms could be assembled to recreate the original Art Deco design of the bridge. The ability to form these repairs and pump the repair mortar inside the forms proved to be one of the main keys to success. Earlier attempts to address the repairs using shotcrete yielded a great deal of waste due to “rebound” of the pneumatically applied mortar, as well as problems with delamination. In contrast, using the form-and-pump method relies on the form to help hold the repair mortar in place while it gains strength and cures. In addition, the impermeable form creates an ideal curing environment in that the moisture is better retained within the repair mortar, such that shrinkage cracking is greatly minimized versus the shotcrete method of repair.

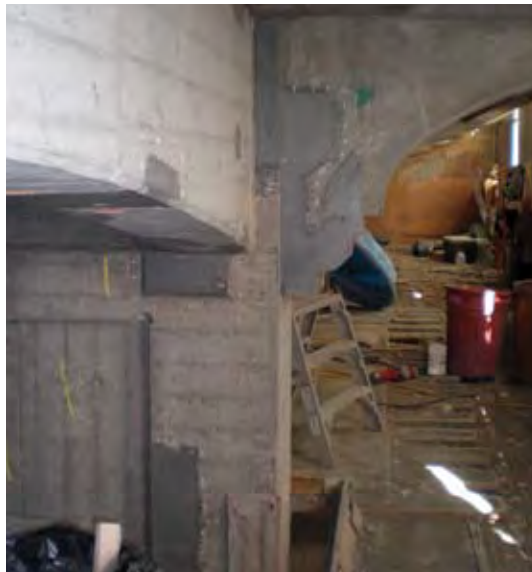
More complex, three-dimensional repairs can also be completed with the solution created by the team. Forming and pumping does not limit the repair to flat surfaces. Note the architectural corbel formed just right of center. Remnants of the white plastic tapit shells are still in the wall, used to hold the form in place

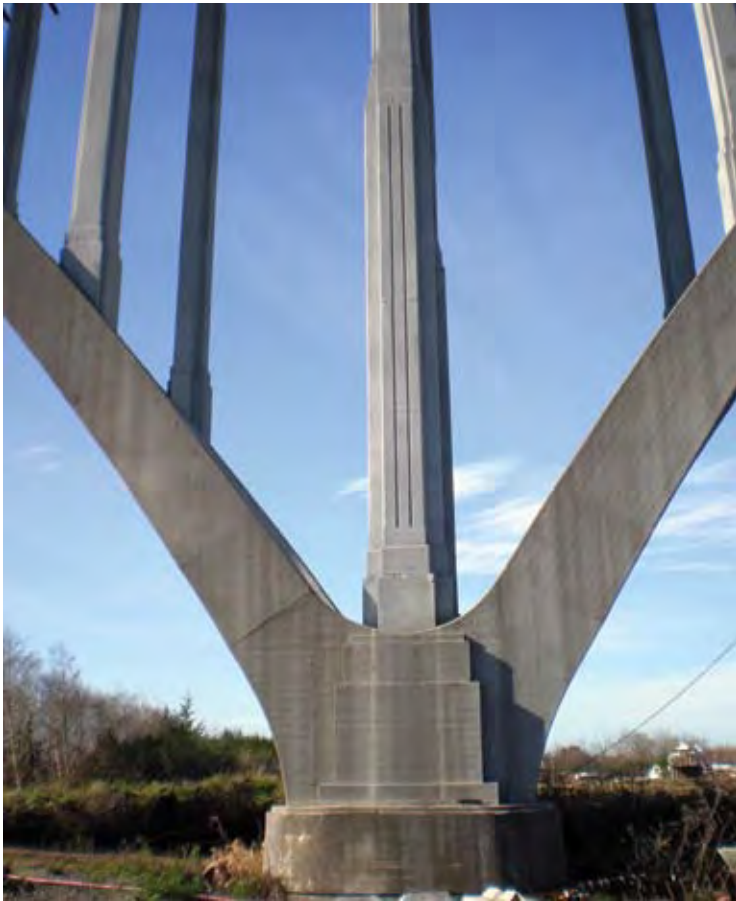
Inside the enclosure you could see the series of platforms that reached out to the center of the enclosure, which was currently erected around one of the main support columns. This photo shows the graceful sweeping nature of the design of this bridge. Note how the arches come together from either side to meet the column. The surface of the repairs has been sandblasted and coated with zinc as a part of the cathodic protection system

The method of repair, using the work platform enclosure, required the team to take into consideration cure time and strength gain. The less time spent waiting for the product to cure, the sooner the team could sandblast the repaired surface and apply the zinc coating used as the sacrificial component of the impressed current, cathodic protection system. Through evaluation of the repair mortar, it was determined by the contractor and Oregon DOT that they could keep the forms in place for 3 days, and upon removal at that time, the concrete and repaired surfaces were ready to be sandblasted in preparation for the coating.

The object of the cathodic protection system is to redirect the corrosion activity, which normally would occur in the structural steel reinforcement (reinforcing bar) out to the surface of the structure. To do so, the concrete must be uniformly and electrochemically conductive. The addition of the salt to the repair mortar enhanced the conductivity of the structure, whereas a low-voltage electrical current is used to help drive the corrosion to the zinc coating—sacrificing the zinc coating before the reinforcing bar—protecting the stability and life of the bridge.
