Transportation Category

Conde McCullough Bridge Repair—South End

Coos Bay, OR
Submitted by BASF Corporation

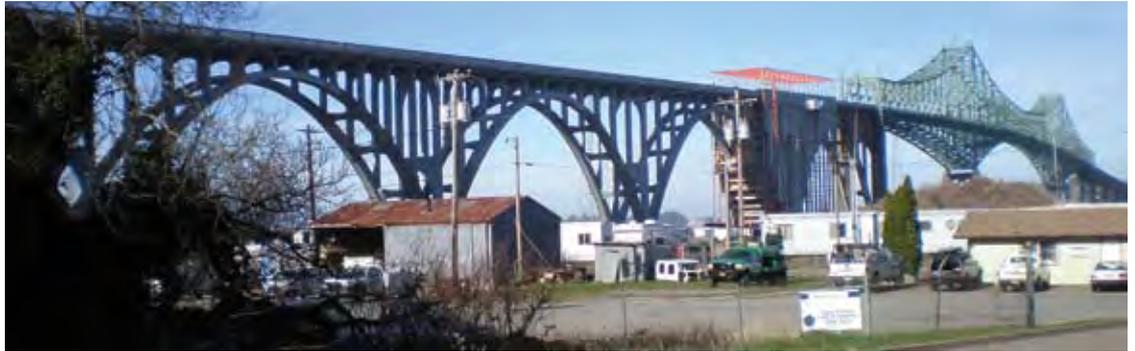
South end of the bridge. Enclosure is visible right before the steel midspan. Scope of work was to repair the South end, a 4-year project

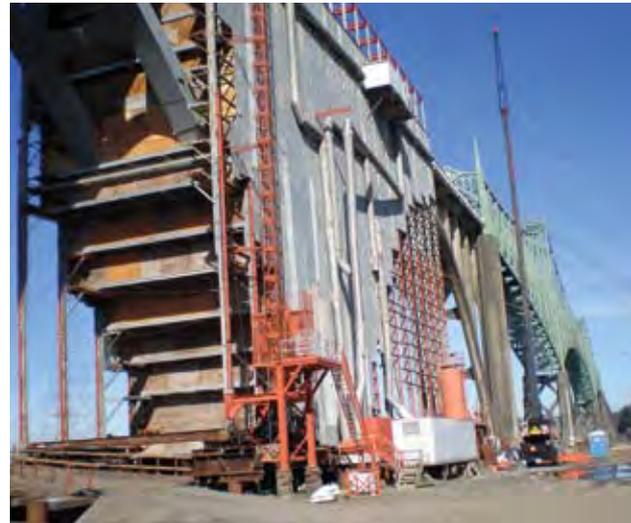
Up-close image of the enclosure showing a perspective of the size of the bridge and complexity of the project. The enclosure is roughly 100 ft (30.5 m) by 120 ft (36.5 m) long. Once the work inside is complete, the enclosure is dismantled and then moved down the line. At the end of the enclosure, you can see a stepping pattern as you follow from top to bottom. Each step represents a repair level—near the top there are “split levels”—16 total to address the complete structure

To address the severe weather conditions, a resilient, movable enclosure was built to create work platforms with multiple levels. Once the work was completed in the section covered by the enclosure, it was disassembled, moved, and reassembled to address the next section of the bridge to be restored. The unique enclosure, which is approximately 100 ft (30.5 m) tall and over 100 ft (30.5 m) long, operates on hydraulics to adjust for the varying height of the bridge. When the section repair was completed, it took approximately 1 month to move the complete enclosure forward to the next repair section.

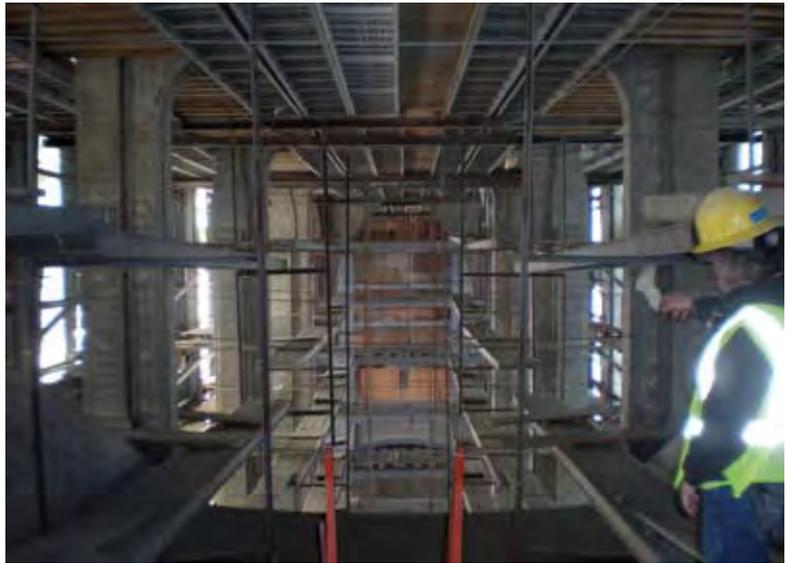
Inside the enclosure, showing the various levels and work platforms

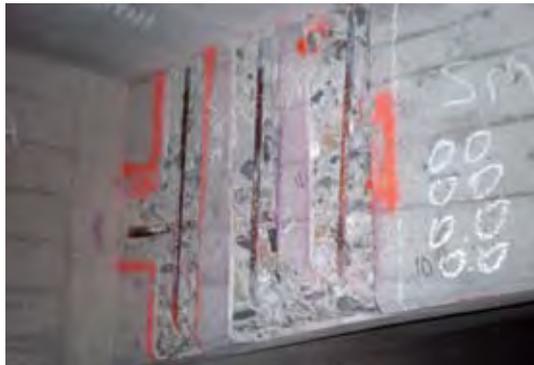
The repair has been prepared. Rather than cutting out reinforcing bar, the surrounding concrete is prepared and a box form will be built around it

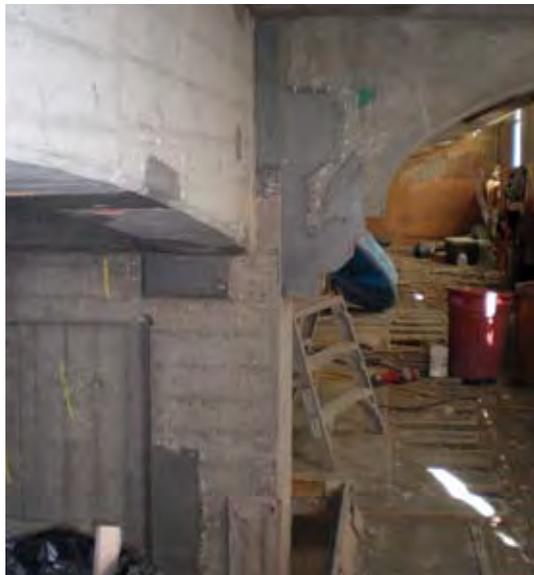
More complex, three-dimensional repairs can also be completed with the solution created by the team. Forming and pumping does not limit the repair to flat surfaces. Note the architectural corbel formed just right of center. Remnants of the white plastic tapit shells are still in the wall, used to hold the form in place

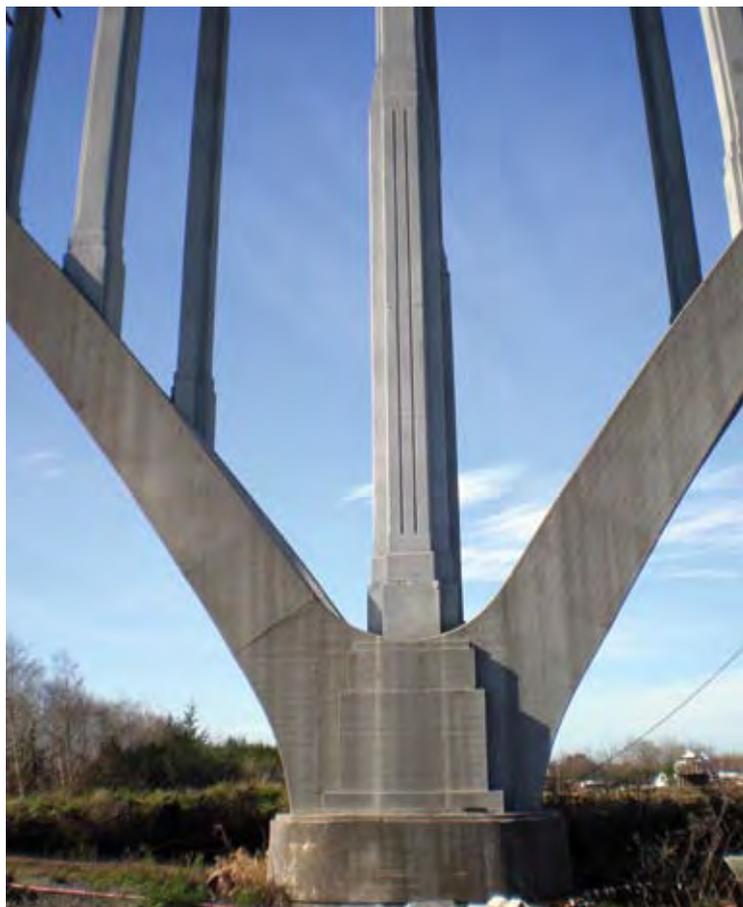
Inside the enclosure you could see the series of platforms that reached out to the center of the enclosure, which was currently erected around one of the main support columns. This photo shows the graceful sweeping nature of the design of this bridge. Note how the arches come together from either side to meet the column. The surface of the repairs has been sandblasted and coated with zinc as a part of the cathodic protection system

The object of the cathodic protection system is to redirect the corrosion activity, which normally would occur in the structural steel reinforcement (reinforcing bar) out to the surface of the structure. To do so, the concrete must be uniformly and electrochemically conductive. The addition of the salt to the repair mortar enhanced the conductivity of the structure, whereas a low-voltage electrical current is used to help drive the corrosion to the zinc coating—sacrificing the zinc coating before the reinforcing bar—protecting the stability and life of the bridge.
